#### ModTiger Reinforcement Kit Installation ©

November 2006

# ModTigerEngineering-TechTips

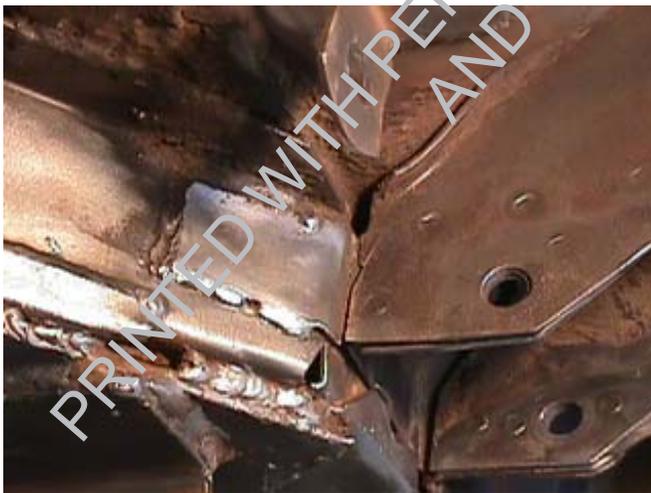
Before we get into the actual procedures to install the various pieces of this kit, I'm going to show you a few pictures that will help you decide if you need this type of reinforcement now, if you can put it off for a while, or your problem is even more serious. Figure 2, below shows the typical Tiger frame in the area of the rear spring attachment. The area shown has obviously been cleaned up and stripped of undercoating. It is much harder to see this failure when it hasn't been cleaned. It remains one of the most common fatigue failure points in the Tiger.

Figure 2. This is what most owners will find when they examine the front mounting area for the leaf springs. This crack is only the most visible failure point. It occurs because this location is a natural "hinge" in the chassis structure where the rear sub frame joins the body tub and X member.

The MTE Structural Repair Kit is designed to Bridge the natural hinge existing in the Tiger chassis. The plates are to be formed as required and welded to the various chassis components thus carrying the stress loads across this area. Appropriate repairs to minimize existing damage and separation of chassis components are the responsibility of the owner. If you find damage greater than that pictured, professional chassis repair is recommended.

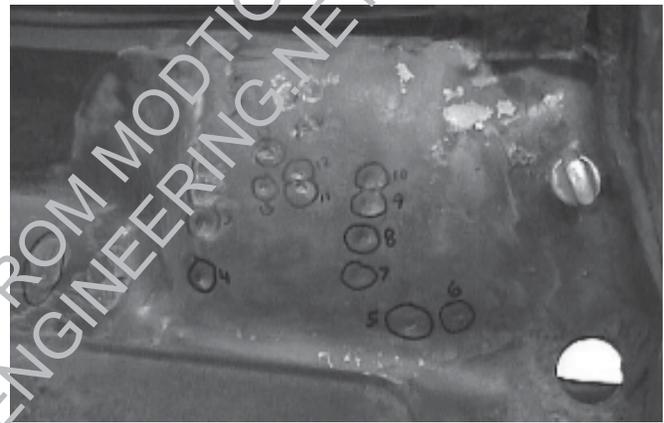
The photo's below are inside the passenger compartment behind the seats. The rear subframe assembly is spot welded to the body tub and these welds are what you are looking at. When the frame tab (shown in Figure 2) cracks, these welds begin to assume the structural loading. They begin pulling apart and the local "dishing" of the floor pan leads to the cracking evident in these photographs.

Figure 3. Here we have an overall shot of the spot welds behind the drivers seat. You will have to do a lot of cleanup to get down to this level.

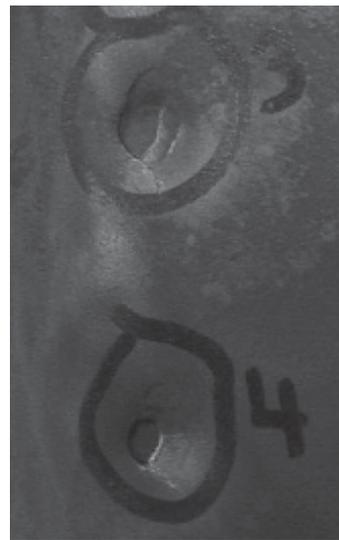
Figure 4. Here we have a closeup of the spot welds shown above. It is clear that the floor pan is failing and that the rear sub frame is pulling away.

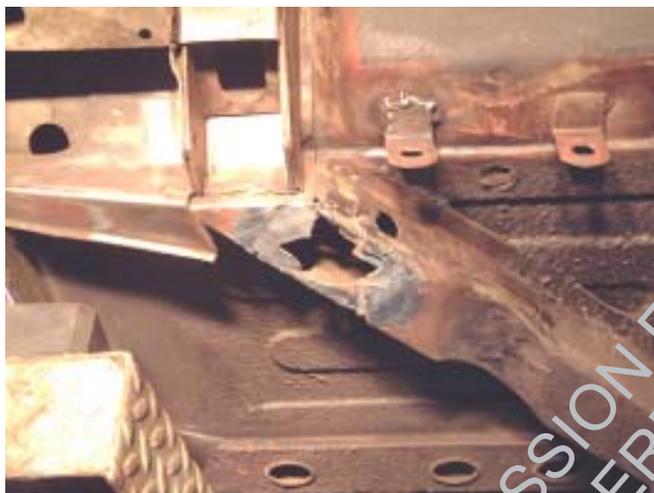
*Figure 5. Here we have a typical Tiger frame that has "lost" the Weld-On Traction Master frame mount. The Weld-On mount is one of the weaker points and has often been torn off and re-welded to the X-member several times, resulting in this kind of damage. My recommendation is to switch to the Bolt-On design for the traction bars or eliminate them and use the Dan Walters developed Torque Arm (909 926-1572).*

Figure 5 above also shows generally the area that needs to be cleaned and prepared for the kit installation. You need to get down to bare metal to obtain the best welds. If the damage to your chassis is worse than that pictured above, the repairs may well be above the scope of this installation procedure.

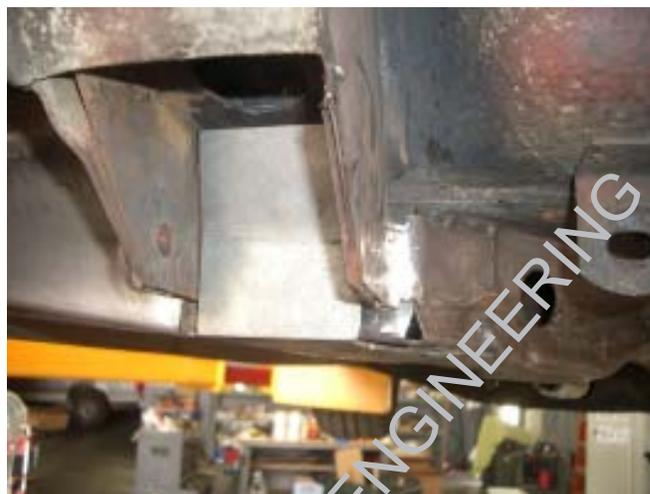
*Figure 6. Here is the rectangular piece, bent and placed into position. Note that it is just below flush with the bottom of the chassis. You will be welding this edge, so you don't want it too high.*

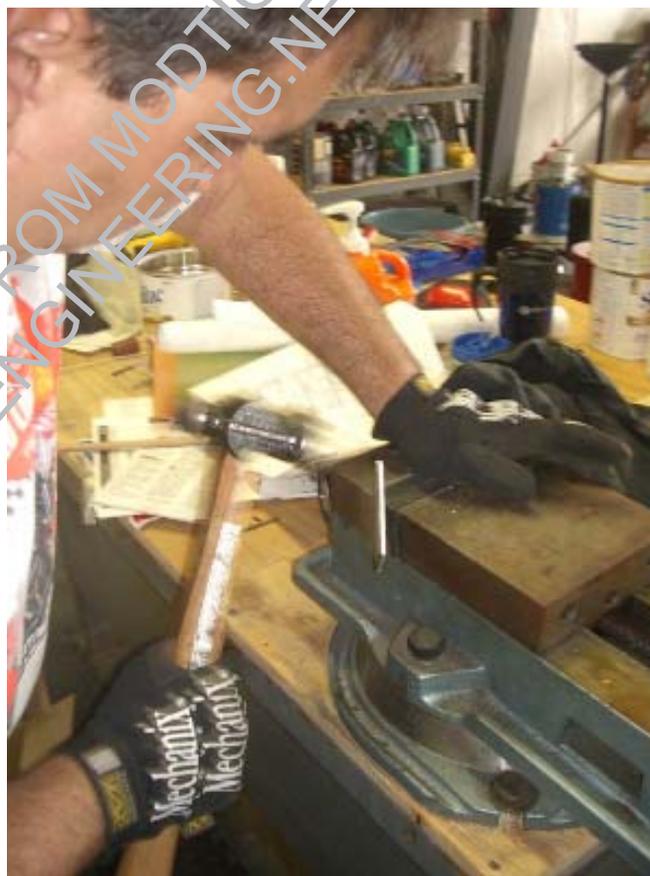
*Figure 7. Here you can see how the side plate is bent to fit. Take your time and work this piece gradually. It's easier to bend it a little at a time than to unbend and rebend. If the location of the bend is not obvious to you, cut a replica out of cardboard and fit that first. Then transfer the bend location to the steel piece.*

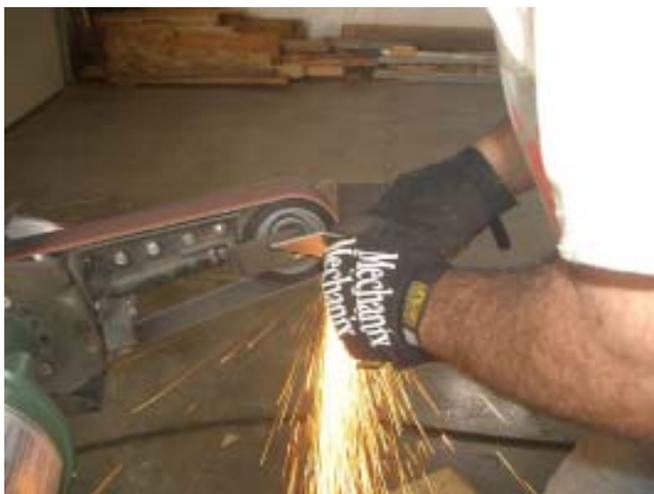
Figure 8. Here we "adjust" the shape to make the perfect fit.

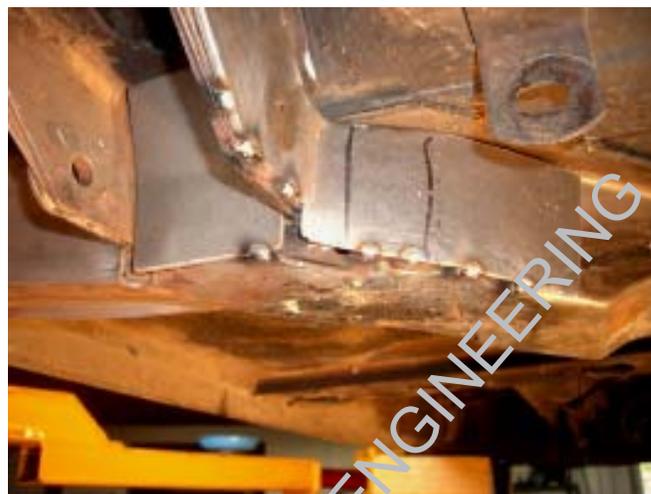
Figure 11. The first two pieces of reinforcement have been fit and tack welded into final position.

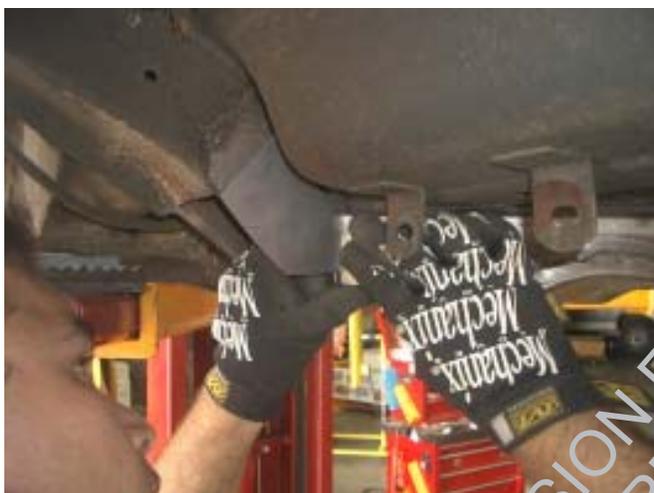
Figure 9. "Fitting" the side piece to the chassis

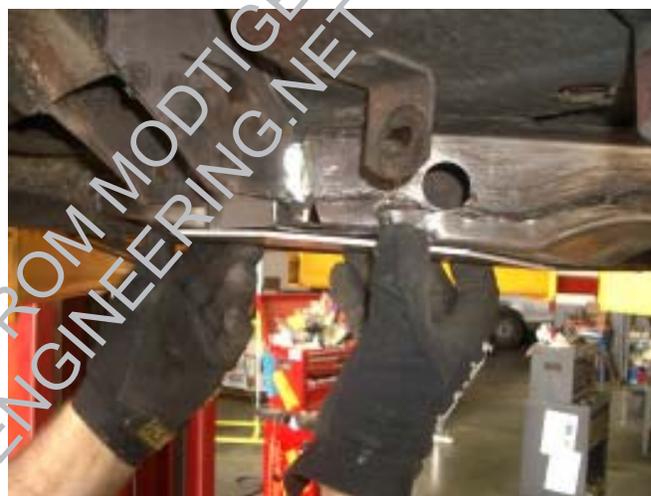
Figure 12. The bottom plate should be a pretty close fit to the side and inside piece where they will be welded together. Some angular adjustment may be necessary with the sanding belt. It's also a good idea to hammer the metal to form joints that can be welded into a tight configuration so that the end result is as smooth and uniform as possible.

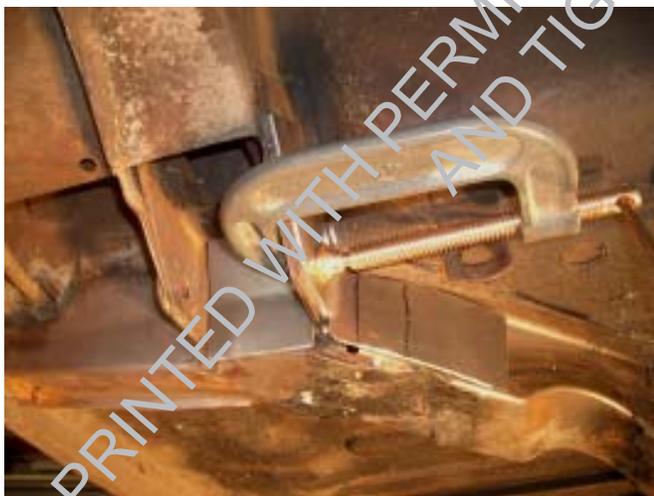
Figure 10. Here's the side piece and the front piece clamped into position, ready for tack welding.

Now that these pieces are fit, we're ready to tack them into position. Remember to leave a little (approximately 1/16") hanging below the OEM structure for attachment of the bottom piece of reinforcement.

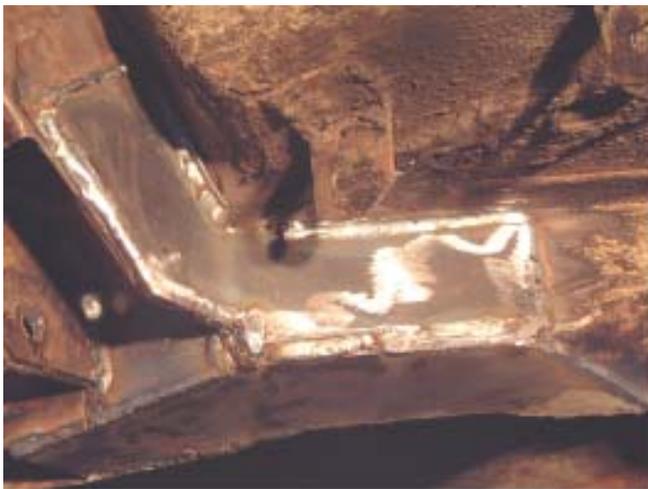
Figure 13. Here we have the finished application to the kit to the rear spring mount. Some minor weld dressing has been done and more can be done, but this gives you the general idea.

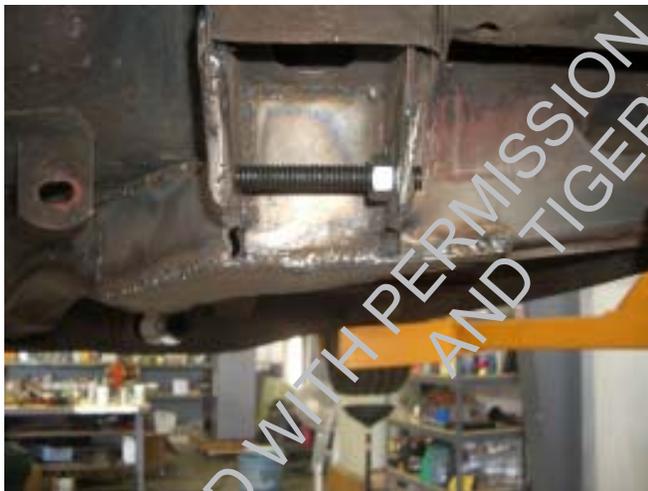
Figure 14. Here's my drill fixture. It's a piece of 7/16 threaded stock with a 1/4" hole drilled through the center. Inserting this piece and tightening the nut as shown, allows the center of the inner hole to be pilot drilled avoiding any enlargement of the original 7/16 hole.

With the welding and grinding done, one task remains and that is to complete the 7/16 Dia hole for the spring mounting bolt. I've done this two ways. One was to use a 7/16 reduced shank drill with my angle drill, and simply drill through from the outside. The second requires a piece of threaded stock with a center hole. This allows a smaller pilot hole to be drilled through the reinforcing plate, which can then be enlarged from the center of the chassis, without gouging the OEM hole as the direct 7/16 drill sometimes does.

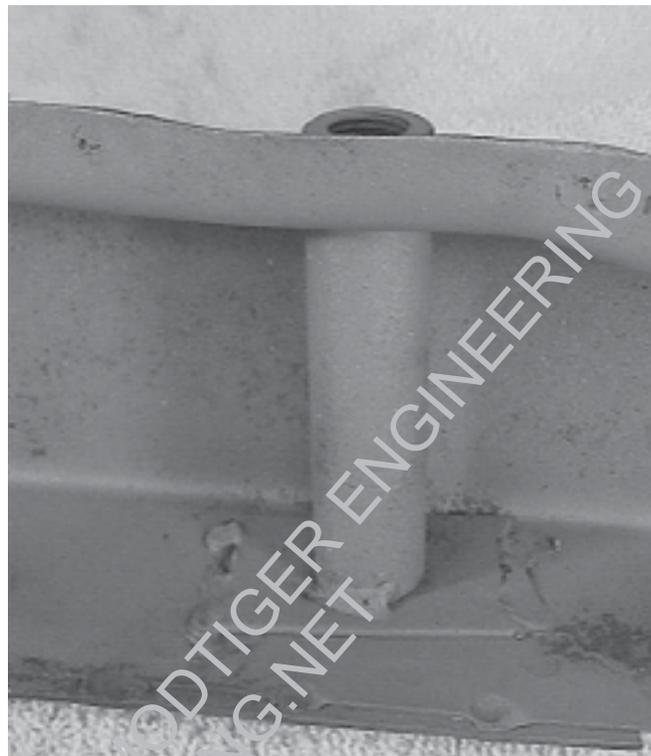
Figure 15. This is what you'd find if you looked inside the front frame horns. As you can see, the tubenut is simply tacked in place.

The front tubenut, located in the frame horn, accepts the connecting bolt from under the crossmember, connecting this structure to the chassis. As you can see in Figure 15, this assembly is rather simple in concept and is now showing up repeatedly as a major weak point in the front of the Tiger chassis. Every application of the brakes applies a twisting load on the front crossmember and the two front bolts take the majority of this loading. The result of 40 plus years of this service frequently points out the weakness of the original design. The tubenut is gradually pulled down in the frame, depressing the area around the tack welds that attach the tubenut to the top rail of the frame stamping. This local "dishing" is only the most visable part of this failure mode. The outside bottom frame flange is spot welded together. As the tubenut is pulled farther and farther down by the crossmember, these spot welds (shown in figure 15 above) begin to fail, opening up the bottom seam of the frame and weakening it substantially. The dished area on top bends and fatigues until it cracks, and then, things get worse in a hurry.

You will also notice this damage whenever you remove the front crossmember. This crossmember connection area of the frame is intended to be very flat and any depression seen in the bottom flange of the frame is a result of the loading and fatigue the chassis has experienced. This dislocation damage should be removed before the reinforcing plate is installed. Figure 17 shows the tooling I developed for pulling the front tube nut back up to the proper position. The outside edges of the frame horn flange may also require cleaning and welding if the OEM spot welds have failed.

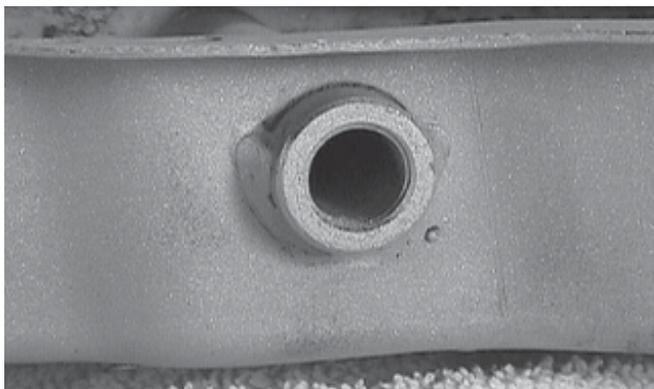
Figure 16. This is an "undamaged" frame connection at the front tubenut. If yours doesn't look like this, some level of repair is in order.

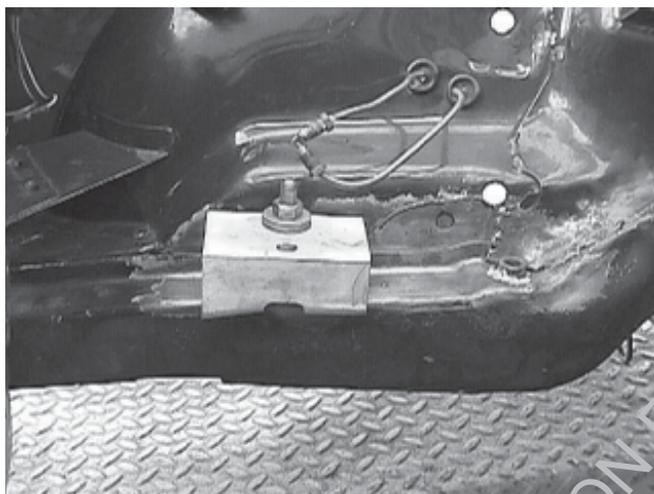
Figure 17. This is a tool I developed to pull the front tube nut back to its original position, without damaging the shape of the frame.

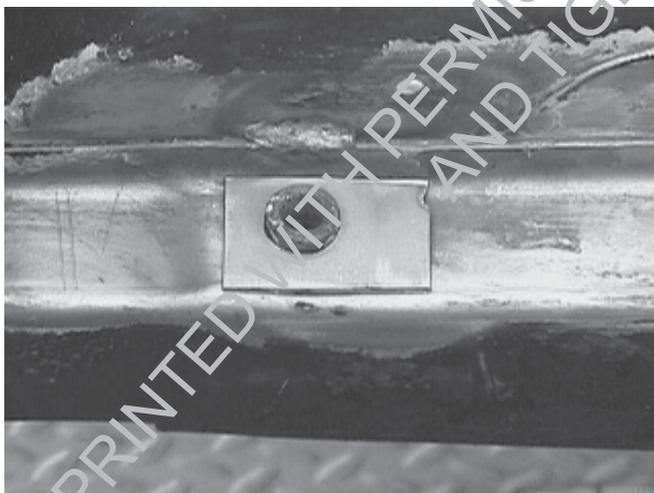
Figure 18 Here's the location of the front tube nut with the reinforcing plate in place, but unwelded. The concept is that this plate, when welded to the top of the tube nut, can carry the loads to the sides of the frame stamping. To assure this load transfer, the perimeter of the reinforcing plate is welded to the frame. In order to get this plate to fit flush as shown, some combination of grinding of the factory welds and countersinking of the hole, from the bottom, is necessary.

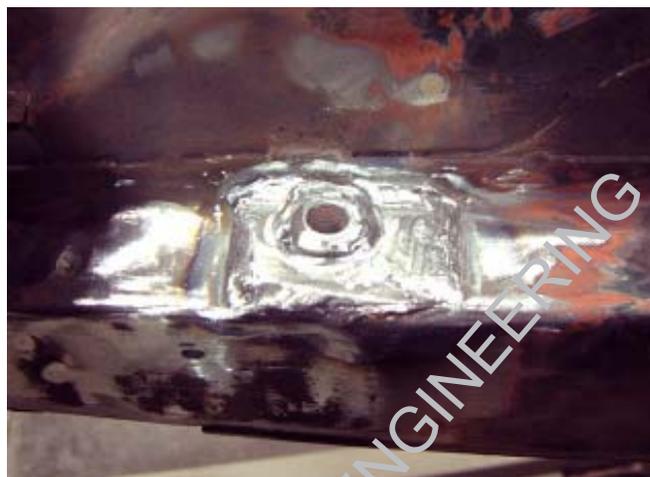
Figure 19. Here's the completed front tubenut reinforcement welded and completed. If you get this reinforcement piece applied before the tube nut starts its typical fatigue failure mode, you can save a lot of future problems and help keep your Tiger structurally sound.

Figure 19 shows the completed reinforcement at the Tubenut. You can make it a little neater with a TIG welder, but in any case, you're going to want to weld all the way around the plate and the tubenut. Be careful when welding the tubenut to the plate, as you don't want to melt into the threads. It's also a good idea to chase the internal 1/2-20 threads after you finish welding. This is a place that collects a lot of debris over the years and chasing the threads will save wear and tear on both the nut and the crossmember connecting bolts.
