TECHNICAL TIPS

ON THE SUNBEAM TIGER

June 1999

URETHANE BUSHINGS AND ALL STEEL BALL JOINTS ARE FINALLY AVAILABLE

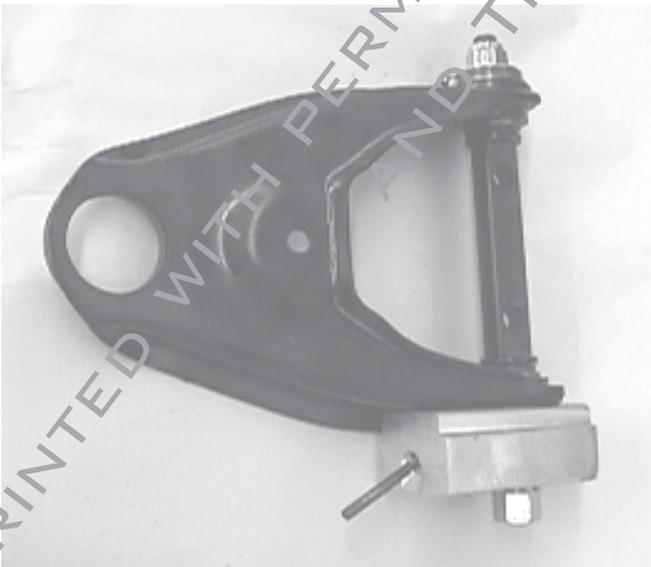
Figure 4. Here's the drill fixture mounted on the upper A-Arm with the #3 tap drill protruding. Note that this modification would normally be done before bushing installation

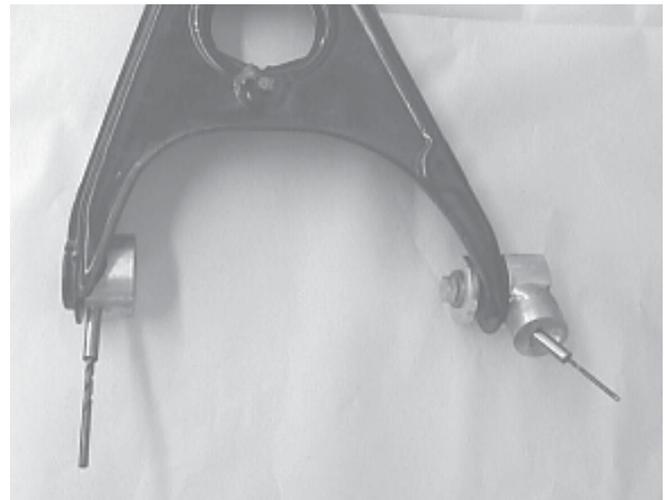
Figure 5. This view shows the straight and angled fixtures for the Lower A-Arms. If you choose to drill your Arms for fittings, you would install the rear bushing first so that you could still re-install the drill guide and drill through the shell and urethane media before the fulcrum pin is installed.

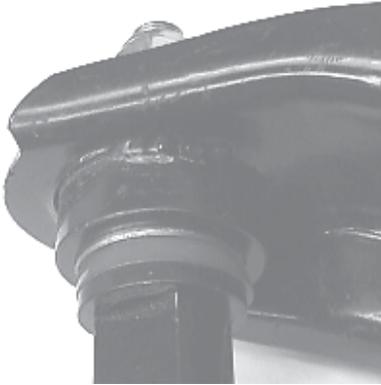
Figure 10. A closeup of the skip weld on the lower bushing shell. This is an important safety modification. Stock spin wells have been known to fail.

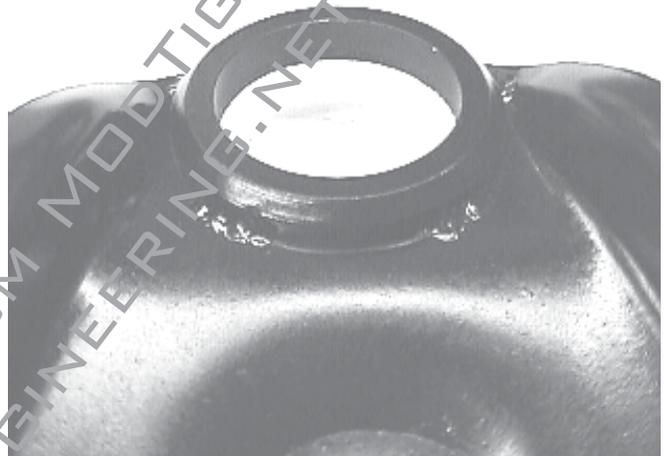
Figure 13. This is a closeup of the skip welds on the ball joint mounting ring and the Upper A-Arm. Installation of a 0.015" larger ball joint is likely to fail the OEM spin weld. This simple skip weld modification maintains this integrity and enhances safety.
